Failure Analysis on Stud Bolts of Chock Valve

ABSTRACT. Laboratory investigation was performed on the damaged stud bolts of choke valve which has been installed on offshore platforms. The used and keep stud bolt of the same production batch were also examined as a reference. The damaged sample was found badly corroded and parted in a brittle manner. The fracture surface of damaged stud bolt was found has a sign of excessive torsional stress. The chemical composition of keep and used samples proven that stud bolts were in compliance to ASTM A320 grade L7 specification. The coating thickness analysis was conducted on keep and used sample by scanning electron microscope using backscattered signal. A significant depletion occurred on the top coat. Metallographic analysis shows the presence of branched cracking on a damaged stud bolt. It proves that there was a slightly residual stress suffered by the damaged sample. The microstructure for keep and damaged sample were tempered martensite whereas the microstructure of used sample was characterized as fine grained ferritic-bainitic microstructure. The laboratory analysis revealed that the root cause of failure was primarily as a result o

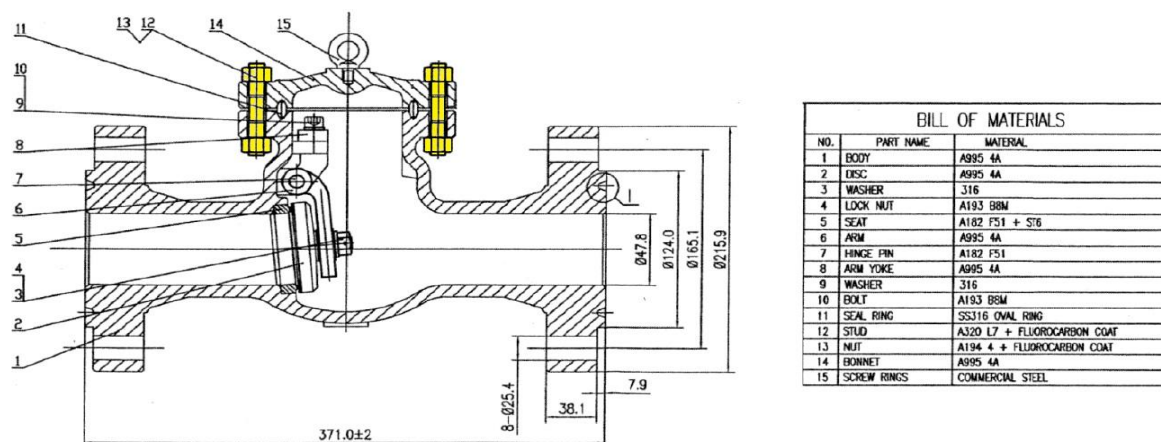
In this case, an investigation has been carried out for stud bolts installed at a choke valve in one of the Malaysia's offshore platforms. The damaged bolts were assembling the body and bonnet parts of a choke valve. According to valve general drawing (Fig.1), body and bonnet material was duplex stainless steel (ASTM A995 4A), while bolt and nut materials were ASTM A320 grade L7 and ASTM A194 grade 4 respectively. General drawing has specified fluorocarbon coating for bolts and nuts. The coating systems include a cermet basecoat, which provides the corrosion resistance, and a fluoropolymer topcoat, which is intended to reduce torque-up friction. According to the client, stud bolts had been assembled in vertical position and had been in service for less than two years. This paper reports the failure investigation of damage stud bolts of choke valve. Some materials characterization of keep and used stud bolts was also reported as a reference

Fig. 1 Assembly drawing of choke valve. The stud bolt was marked in yellow color

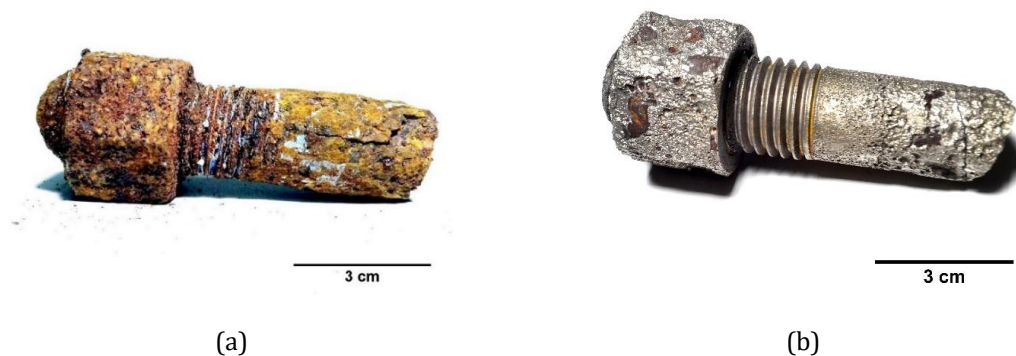
The visual inspection found that the keep stud bolt appeared as a dark-blue coated color. The used stud bolt sample was worn and faded to be light-blue, there were some light scratches on the surface and rusty threads. Although it has been used for 2 years on the choke valve on the same platform, but this sample still looks good and can be operated in service again. The damage sample was catastrophically parted and appeared as badly corroded stud bolt (Fig. 2a). Some coating layer was observed still remain on the surface. It shows the uniform corrosion was penetrated under coating layer. Fig. 2(b) shows the as-cleaned of damage sample. When the rust was cleaned, then it was obvious that bolt studs were mainly suffered by uniform corrosion and some wide and shallow type pitting in several areas. Visibly, the stud bolts were parted with no visible distortion. All of the stud bolts were fractured in the brittle manner and this normally happens to hardened steel which known has brittle properties.

Fig. 2 Camera photographs of (a) as-received damaged and (b) as-cleaned of damaged stud bolt samples

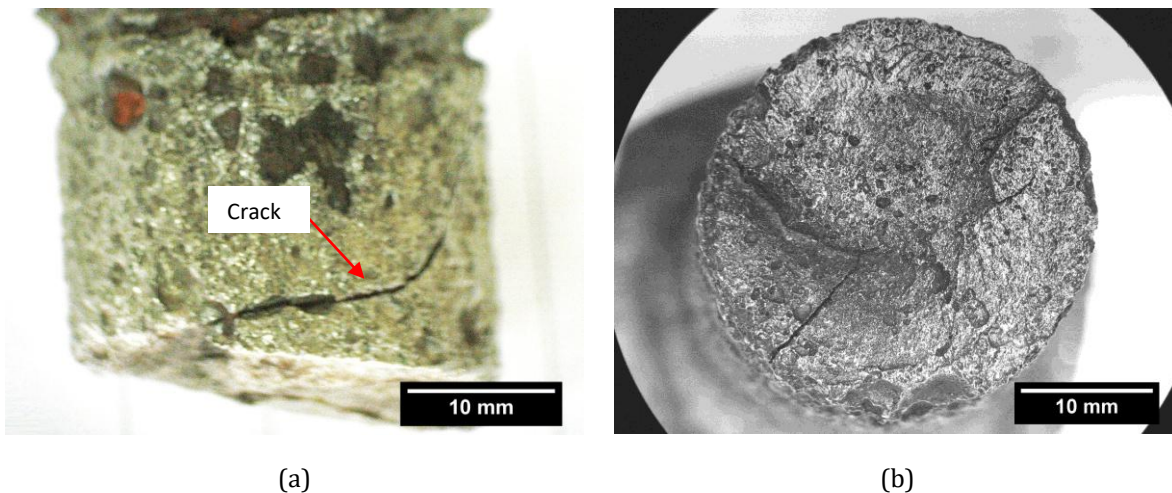
The closed-up photographs by stereo-microscope on damaged specimen were displayed in Fig. 3. As referred to Fig. 3(a), the excessive transverse cracked occurred at 30° to 40° direction which indicates that there was a torsional stress effect. The pitting corrosion marks on the stud bolt surface were seen. Fig. 3(b) shows the fracture surface of the parted stud bolts. Generally, the fracture looks like a torsional fatigue failure. This photographic image illustrates the fault that begins on the outer surface and ended at the center of the stud bolt bar. It was not very clear due to rust effect, nonetheless there were some multiple crack nucleation sites around the outer surface. With residual stress together with the vibrations inherent as the operation of the choke valve, the stud bolt finally cracked, propagated inward and finally breakdown at the center.

Fig. 3 Stereo microscope image on as-cleaned failed stud bolts focusing on (a) side and (b) top of the fractured area

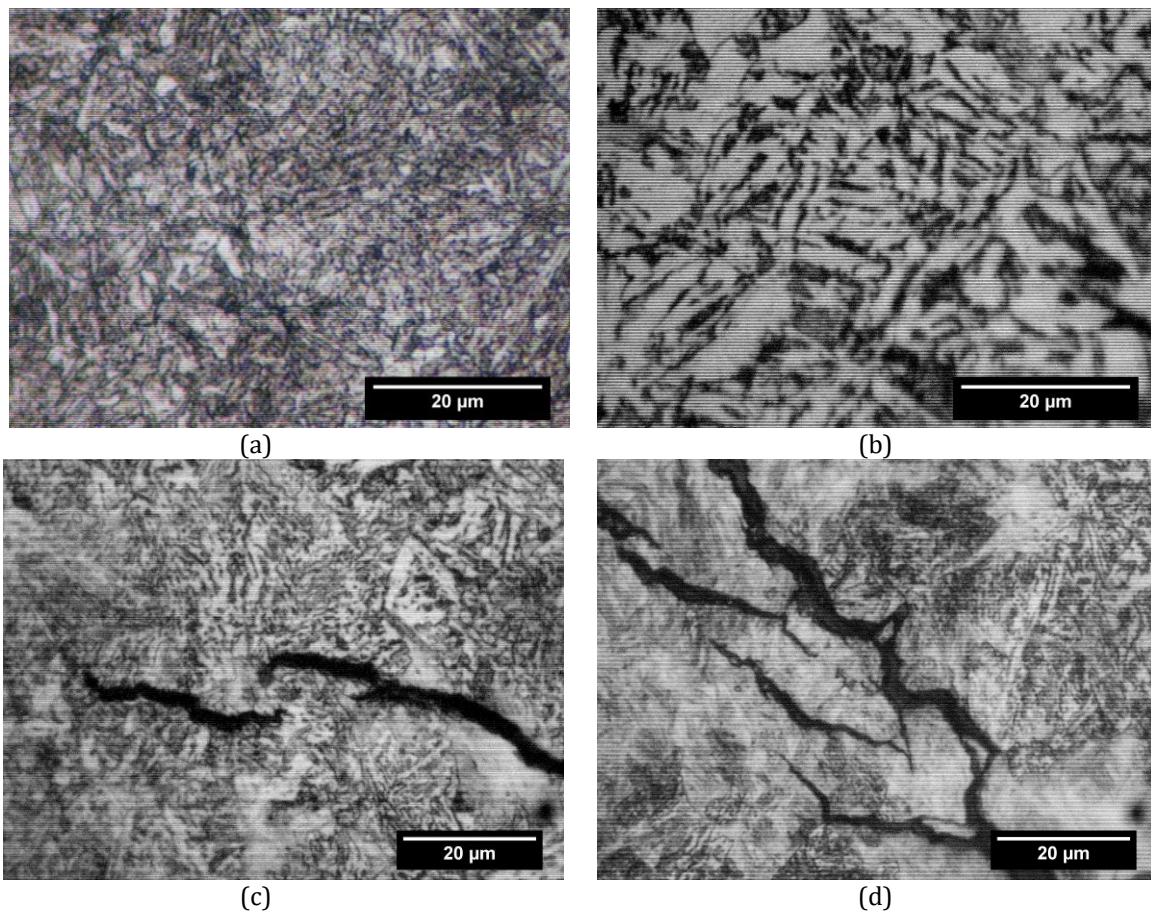
Metallographic analysis was carried on keep, used and damaged stud bolt samples. The keep sample consists of some ferrite (white) in fine tempered martensite (Fig. 4a) whereas the structure of the used sample was ferrite (white) and carbide (black) constituents in fine grained ferritic-bainitic microstructure (Fig. 4b). Microscopically, the damaged stud bolt structure consisted of largely tempered martensite with the formation of cementite particles at the martensite lath boundaries and within the laths (Figs. 4(c,d)). The cracks occurred transgranularly (Fig. 4(b,c)) and branched (Fig. 4d). The transgranular crack proved the fractured was caused by overloading stress, whereas the branched crack demonstrated the stud bolts was suffered by the residual stress during the installation works. As the used sample exhibits a different microstructures than others, it was thus clear that there is an inconsistent pattern of microstructure pattern among the different manufacturing batch of stud bolts. This may happen coincidentally or might be due to a mistake that occurs during the manufacturing process level. However, in the choke valve operation condition at offshore platform, this type of fine grained ferritic-bainitic microstructure have proven that it has a better toughness than tempered-martensite structure. It did not fail under torsional residual stress.

Overall, out of all the analysis findings, it can be summarized that stud bolt bar failure was due to the hardening process of steel that forms a hardened and brittle martensite microstructure. The brittle metal materials are easily to crack or fracture. The probability for contractor worker to make a careless mistakes during stud bolt installation using the torque wrench is might be happened or maybe the installation is done manually. Based on the evidence that there were signs of torsional stress on the stud bolt studs, therefore one of these human errors is indeed true. Therefore, with the metal residual stress due to faulty during installation, coupled with the brittle metal and the vibration condition of choke valve service, then the cracking process has indeed occurred. In addition, the faulty process also occurs due to the depletion of top coat that leads to pitting problems

Fig. 4 Optical metallographs on the etched cross-sectional surface of (a) keep, (b) used and damaged stud bolts shows (c) a transgranular and (d) branch cracking

The application of tempered martensite hardened steel as suggested by ASTM A320 grade L7 could be replaced by ferritic-bainitic steel. The microstructure of ferritic-bainitic steel consists of a softer ferrite matrix with fine bainite as second phase. The second hard-phase bainite and grain refinement make ferritic-bainitic steel a materials with excellent formability, improve stretchability of sheared edges [7]. Ferritic-bainitic steel provide higher strain hardening exponent at the same level

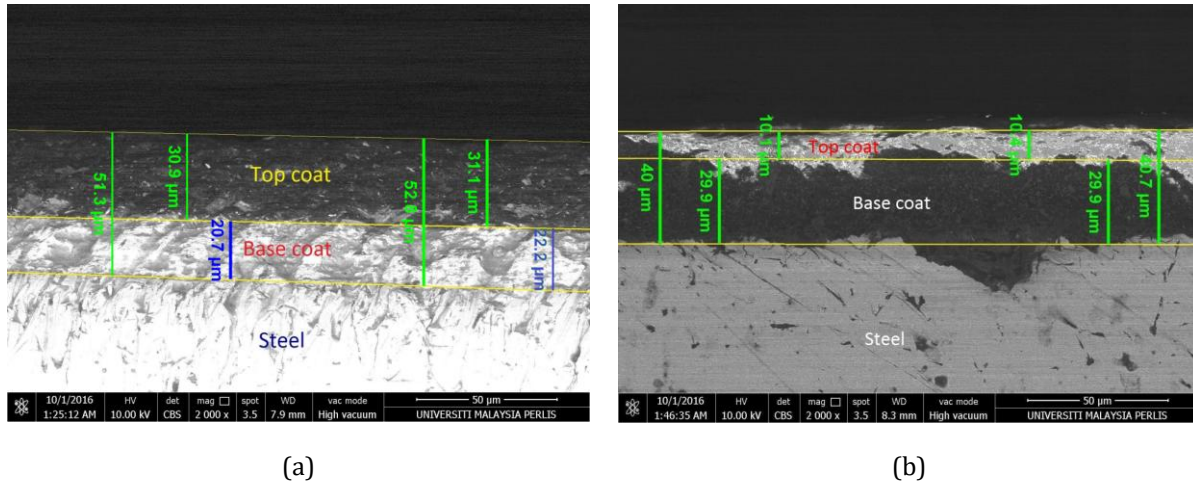
The coating layer thickness was measured by means of scanning electron microstructure as displayed Fig. 5. The thickness of top and base coat for keep sample was approximately 30 μm and 20 μm respectively (Fig. 5a). On the other hand, the damaged specimen meanwhile, suffers depletion problem by time where the top coat decrease to 10 μm (Fig. 5b). The depletion of top coat was also believed to occur with the damaged

sample. The weakness of this top coat causes the exposure of underneath metal to corrosive environment resulted in the occurrence of under-coating corrosion leads to pitting and finally accelerates the crack propagation process of stud bolts.

Fig. 5 SEM micrographs of the cross-sectional surface for (a) keep and (b) used stud bolts to show the thickness measurement

of strength as reported by Pathak et al. [8]. They also good fatigue properties and crash performance, allowing a good performance under dynamic loading [9]. In order to overcome the top coating problems, the coating materials are recommended to replace by pure epoxy materials by electrostatic powder coating technology. The powder coating technology has been known producing a high corrosion resistance, robust and wear resistance.
